**MARINE CORPS AIR STATION EL TORO  
EL TORO, CALIFORNIA  
INSTALLATION RESTORATION PROGRAM  
FINAL RCRA FACILITY ASSESSMENT REPORT**

**VOLUME IV**

**16 July 1993**

**MARINE CORPS AIR STATION  
EL TORO  
EL TORO, CALIFORNIA  
INSTALLATION RESTORATION PROGRAM  
RCRA FACILITY ASSESSMENT  
DRAFT PRELIMINARY REVIEW/  
VISUAL SITE INSPECTION REPORT  
VOLUME II**

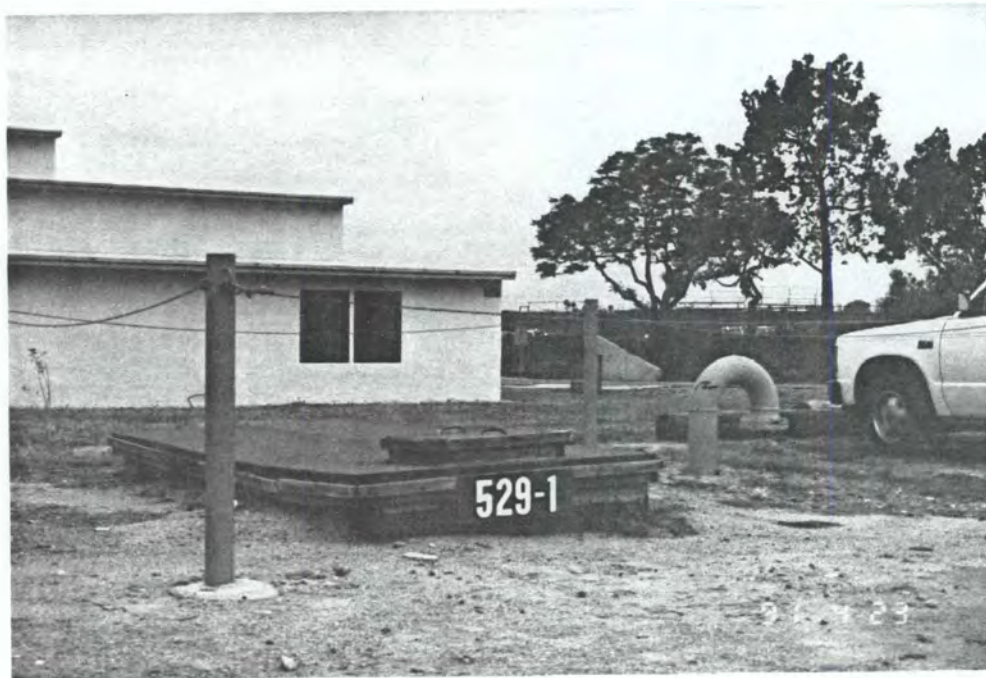
Underground Storage Tank (UST) 529 is located about 25 ft northeast of Building 529. The tank is concrete and has a 25,000-gallon capacity. At the top of the tank is a 5-ft x 12-ft x 12-ft housing structure. The housing structure is covered with a green-colored, asphalt roofing material. Since the tank is located underground, the physical condition of the tank could not be visually observed.

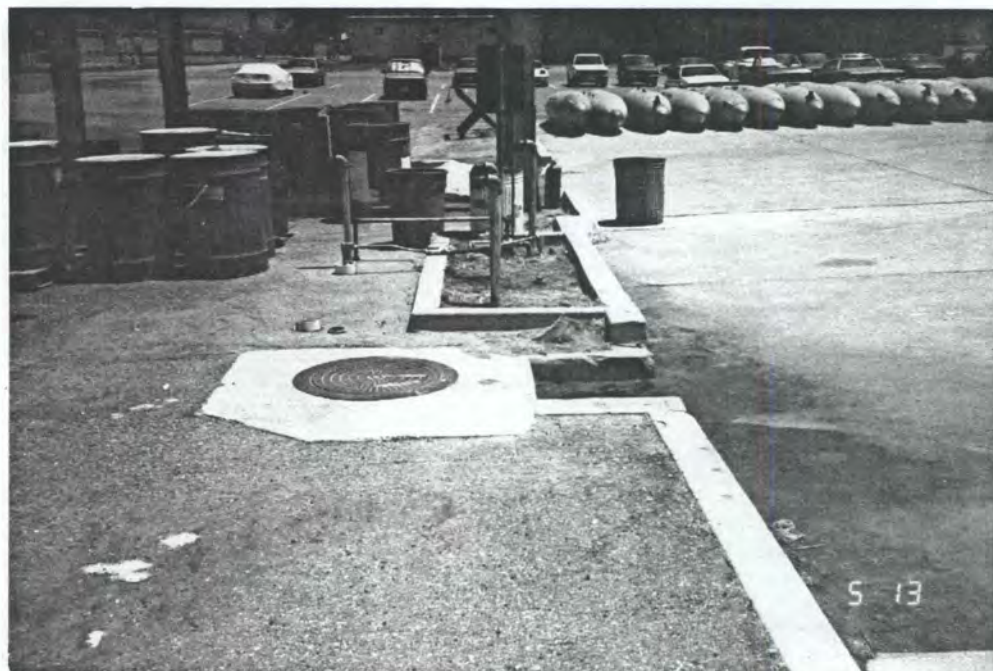
An oil/water separator is located northwest of Building 605. The oil/water separator is associated with the aircraft wash area (SWMU/AOC Number 150) at Building 605. The oil/water separator is located approximately 11 ft west of a DSA (SWMU/AOC Number 149). The drain opening to the oil/water separator is located approximately 8 ft east of the northeastern corner of the bermed concrete washpad. The drain design differs from drains observed at the other oil/water separators on the Station. Instead of the typical approximately 2-ft x 2-ft grated drain opening, the oil/water separator at Building 605 has an approximate 3-in.-diameter PVC drain pipe. The pipe is positioned in the eastern side of the bermed drain inlet area, and apparently leads east to the underground oil/water separator. The drain inlet area and the washpad surface in this area were covered with a thin layer of dark, moist soil, apparently sediment from water pooling in this area of the washpad around the drain inlet. The concrete around this area appeared darkly stained.

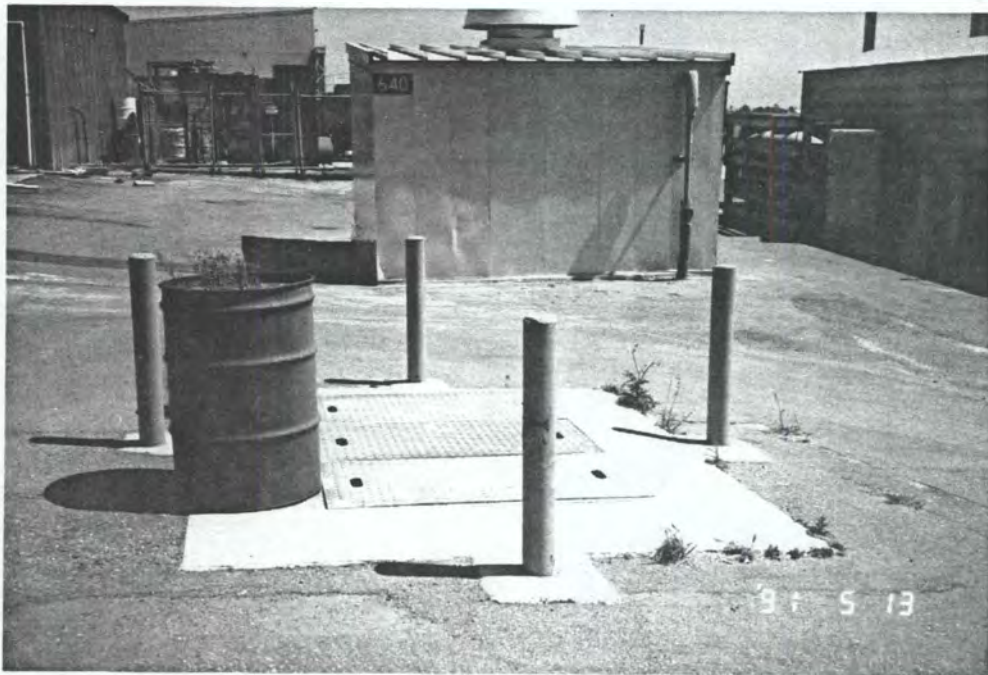
Tank 643-A is a 185-gallon steel-wall UST. The tank was installed in 1982 along with Oil/water Separator 643-B (SWMU/AOC Number 163). Tank 643-A is used to store waste oil residue extracted from Oil/water Separator 643-B. Because the tank is located underground, the physical condition of the tank could not be visually observed. See Evaluation Form SWMU/AOC Number 163 for a description of the locational characteristics of the tank.

This UST has not been tank tested. Although no evidence of a release from the UST was indicated from the records review or the VSI, it is difficult to assess the potential for release from this underground SWMU/AOC. A sampling visit is recommended for this tank.

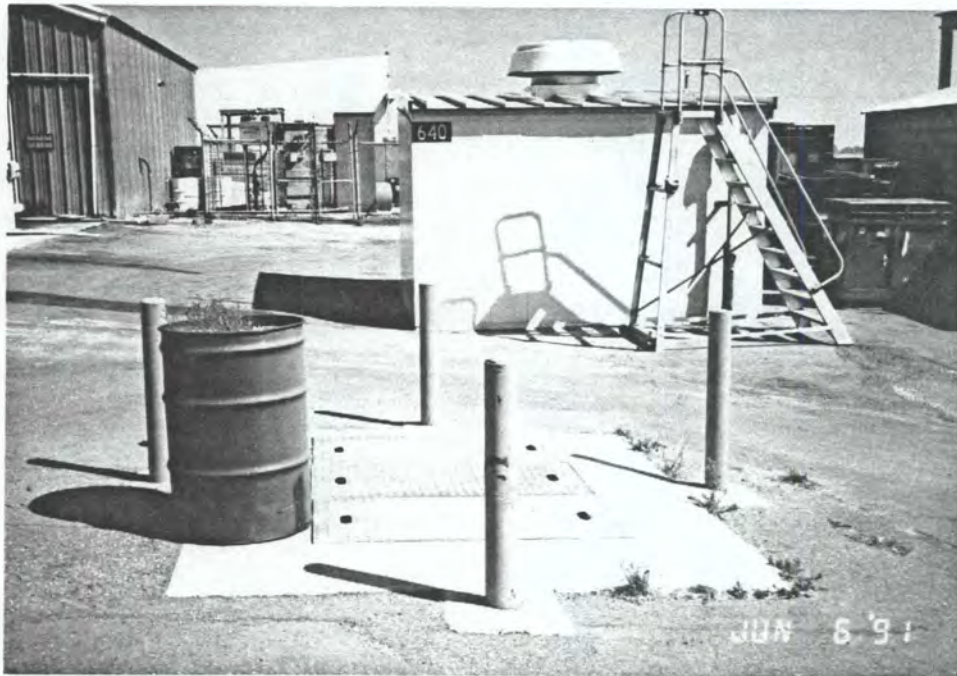
Oil/water Separator 643-B is located between Buildings 643 and 696. The oil/water separator was installed in 1982. It consists of a 100-gallon concrete-wall tank. The location of the oil/water separator is identified by a three-piece galvanized steel cover. The entire cover measures about 5 x 10 ft. The cover protects the vents and discharge pipes associated with the oil/water separator. The steel cover is bordered by a 1-ft concrete surface, which is bordered by asphalt. Because the oil/water separator is located underground, the physical condition of the separator could not be observed. The drain leading to the oil/water separator appears to be located approximately 10 ft south of the washrack at Building 606 (SWMU/AOC Number 152).

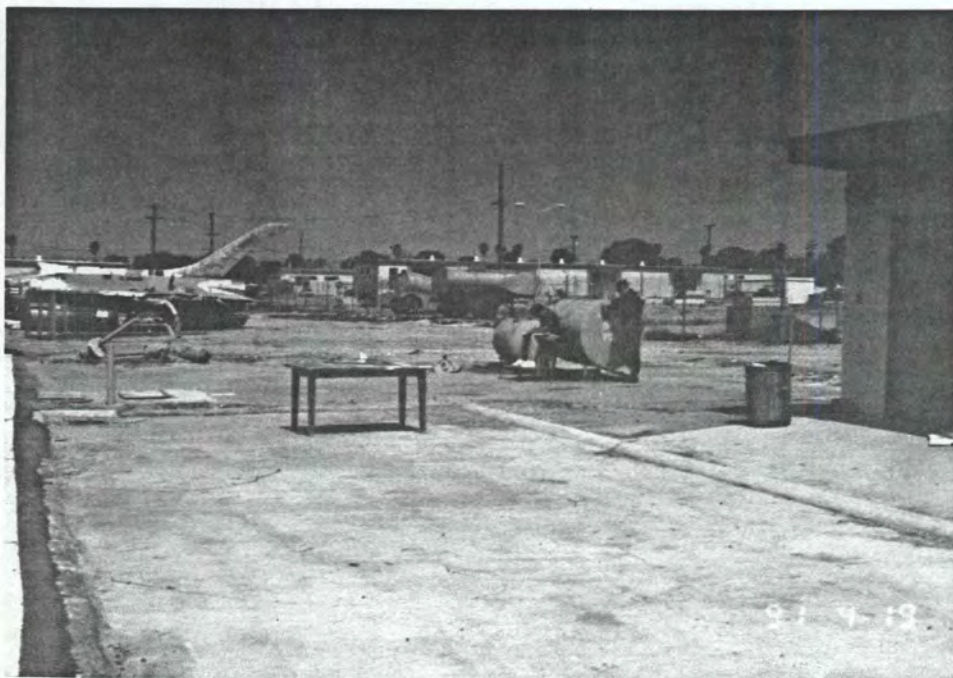
This washrack is located on the west side of Building 763, and southeast of Building 242. It measures approximately 54 ft by 16 ft in size. The washrack consists of a concrete wash pad surrounded by a 6-in. concrete berm. The washrack appears to have been inactive for a while because there are several small mounds of dirt on the wash surface with vegetation growing. A drain leading to oil/water separator 765-B (SWMU/AOC Number 218) is located near the northwest corner of the wash area. There are no significant stains or cracks on the wash pad area immediately surrounding the washrack.

The washrack is constructed of concrete that is sloped to collect the wash water in a drain connected to an oil/water separator. The concrete appeared to be free of cracks or defects that would allow wash water to exit the washrack other than at the drain. In addition, there is no evidence of stains outside of the washrack area. No further action is recommended for this SWMU/AOC.

It should be noted that the receptors of the wash water (i.e., the drainage channels via storm drain and the oil/water separator) are identified as SWMU/AOCs recommended for a sampling visit.

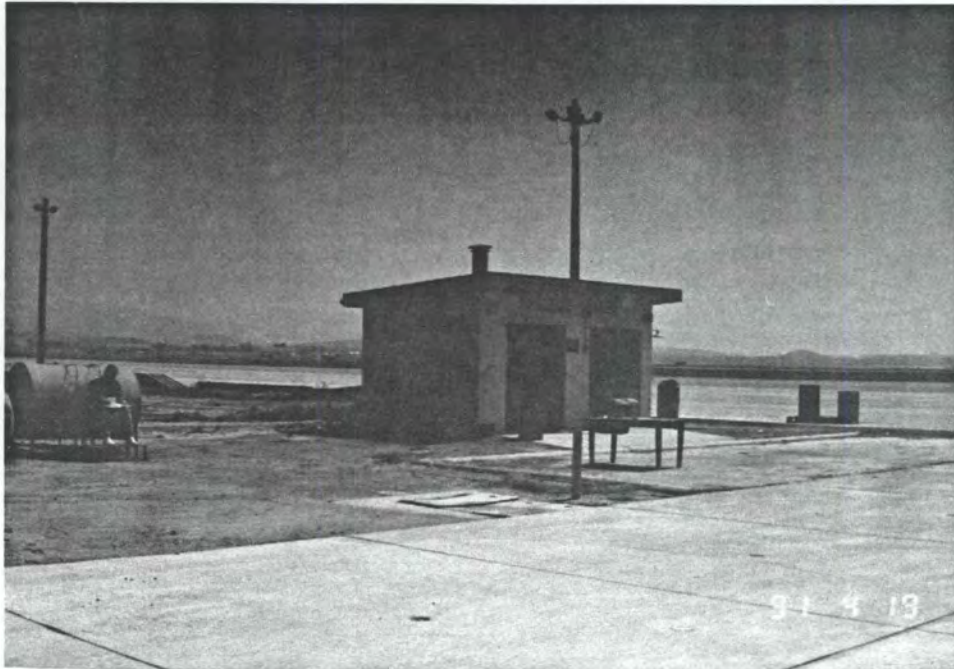
Tank 765-A is a 185-gallon, steel wall, underground storage tank. The tank was installed in 1982 along with oil/water separator 765-B. Tank 765-A is a waste oil holding tank for storing waste oil residue received from oil/water separator 765-B. Because the tank is located under ground, the physical condition of the tank could not be visually observed. See Evaluation Form SWMU/Area of Concern Number 218 (oil/water separator 765-B) for a description of the locational characteristics of the tank.

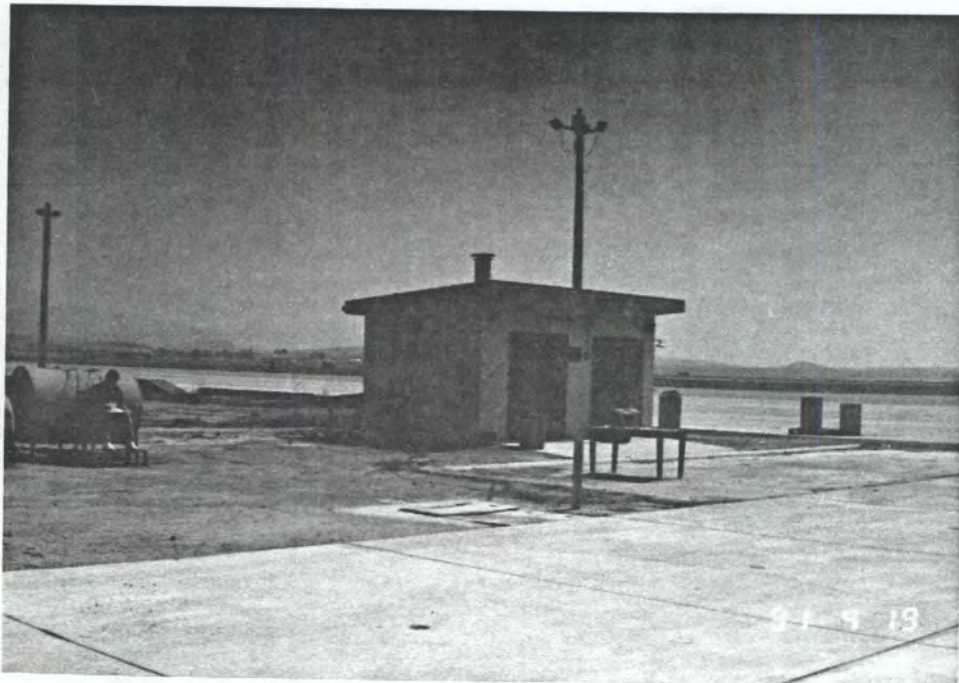
Oil/water separator 765-B is located adjacent to the northwest corner of the washrack at Building 765. The oil/water separator was installed in 1982. It consists of a 100-gallon, steel wall tank. The location of the oil/water separator is identified by a three piece galvanized steel cover. The entire cover measures about 5 ft x 10 ft. The cover protects the vents and discharge pipes associated with the oil/water separator. The steel cover is bordered by 1 ft of concrete surface which is bordered by asphalt. Because the oil/water separator is located underground, the physical condition of the separator could not be observed.

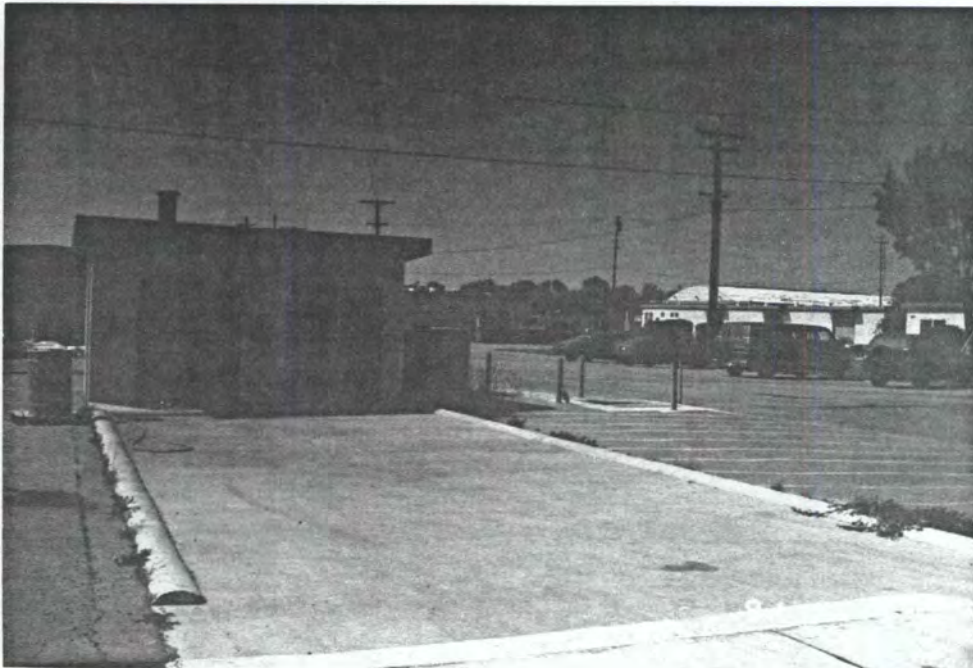
The washrack is located about 100 ft west of the Aero Club. It is used to wash vehicles and small rental aircraft. The washrack consists of a rectangular concrete wash area surrounded by a 6-in. concrete berm. There are no significant stains on the wash area or the area outside the washrack. A 2- to 3-ft section of the berm is missing from the southwest corner of the washrack. The wash rack is graded so that the water drains in a northwesterly direction; therefore it is unlikely that any water would drain out from the missing section. A drain located in the northwest corner of the wash area leads to oil/water separator 766-A (SWMU/AOC Number 220).

The washrack is constructed of concrete that is sloped to collect the wash water in a drain connected to an oil/water separator. The concrete appeared to be free of cracks or defects that would allow wash water to exit the washrack other than at the drain. In addition, there is no evidence of stains outside of the washrack area. No further action is recommended for this SWMU/AOC.

It should be noted that the past and present receptors of the wash water (i.e., the drainage channels via storm drain and the oil/water separator) are identified as SWMU/AOCs recommended for a sampling visit.

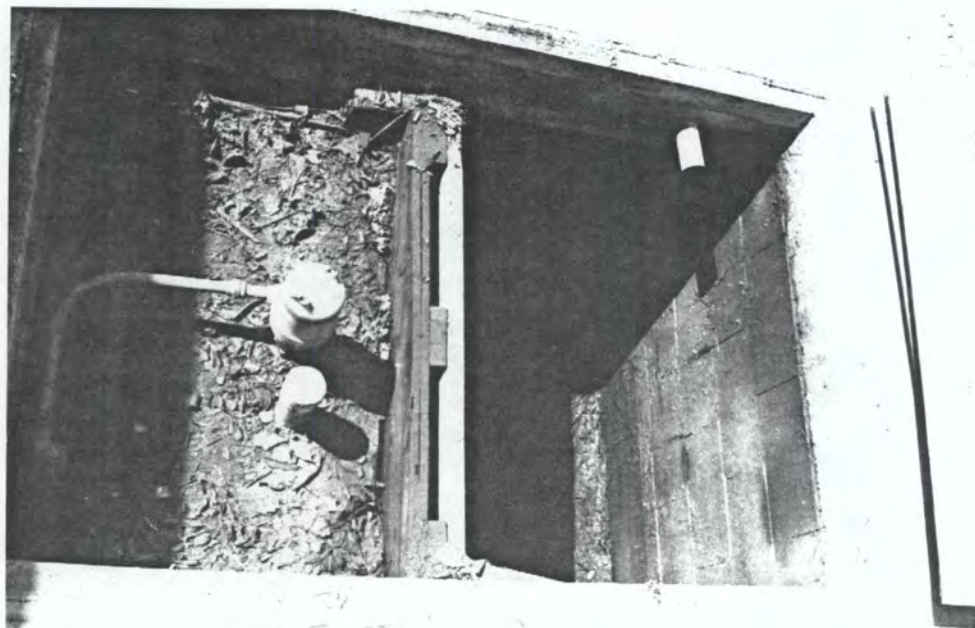
Tank 766-B is a 185-gallon, steel wall, underground storage tank. The tank was installed in 1982 along with oil/water separator 766-A (SWMU/AOC Number 220). Tank 766-B is used for storing oil received from oil/water separator 766-A. Because the tank is located underground, the physical condition of the tank could not be visually observed. See the Evaluation Form for SWMU/AOC Number 84 for a description of the locational characteristics of the tank.

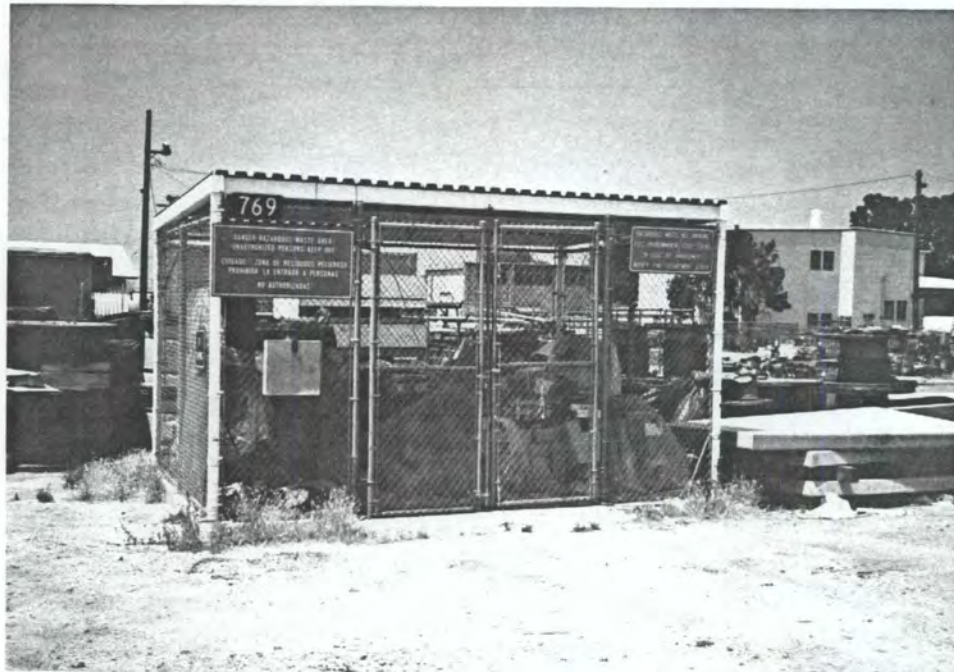
Name: Hazardous Waste Storage Area 769

This Hazardous Waste Storage Area (HWSA) is one of the six DHS-permitted HWSAs at MCAS El Toro. These six HWSAs (SWMU/AOC Numbers 222 through 227) are not planned for future use. Historically, these six HWSAs have had drums stored outside of the storage area. The HWSA is located in a storage yard east of Building 306. The HWSA is built with a concrete storage pad surrounded by a 6-in. concrete berm. The storage area is protected by a chain-link fence and covered by an aluminum roof. At the time of our visit, the HWSA was not being used to store hazardous waste. Various types of electrical equipment (e.g. fans, conduit, copper wire, light fixtures) were being stored inside the storage area. There was also about 4 inches of ponding water covering the storage surface. Because of the ponding water and electrical equipment, the storage surface or berm could not be inspected for cracks or stains.

Although there was no evidence of a release during the site visit and hazardous waste was not currently stored in the area, the past and present HWSAs at MCAS El Toro are recommended for a sampling visit.

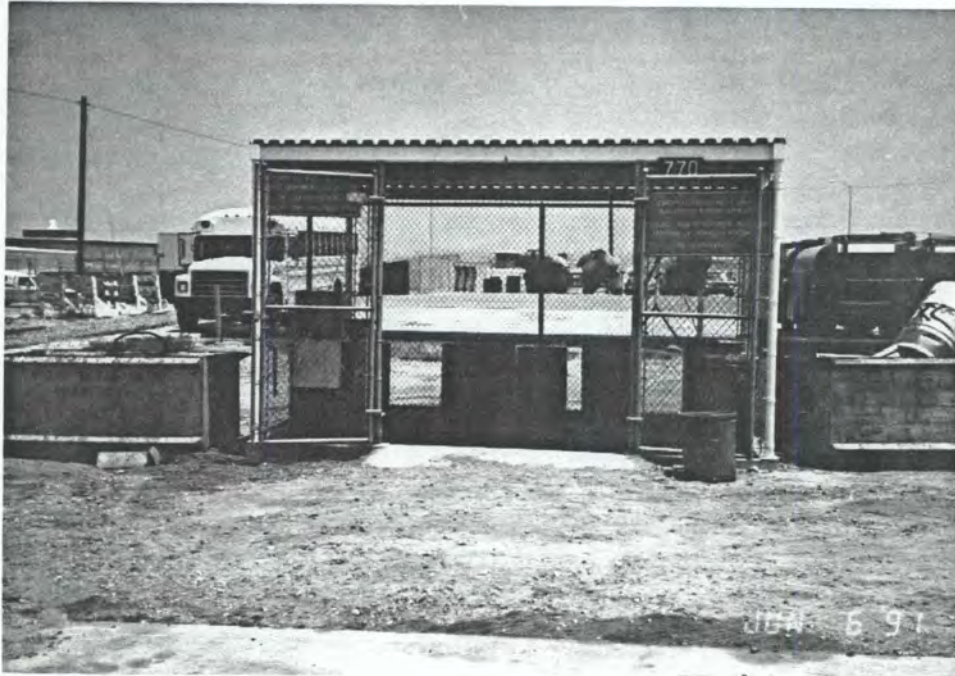
Name: Hazardous Waste Storage Area

This Hazardous Waste Storage Area (HWSA) is one of the six DHS-permitted HWSAs at MCAS El Toro. These six HWSAs (SWMU/AOC Numbers 222 through 227) are not planned for future use. Historically, these six HWSAs have had drums stored outside of the storage area. This HWSA is located about 60 ft east of Building 386 near the southeast corner of a vehicle washrack (SWMU/AOC Number 110). It consists of a 12-ft by 12-ft concrete storage surface surrounded by a 6-in. concrete berm. A chain-link fence and aluminum roof protect the HWSA from unauthorized entry.

At the time of the site visit, the HWSA appeared as if it was being cleaned. All of the drums had been removed and placed on wood pallets outside the southwest corner of the HWSA. There was about 2 inches of water in the HWSA. No significant stains or cracks were observed.

Although there was no evidence of a release during the site visit, the past and present HWSAs at MCAS El Toro are recommended for a sampling visit.

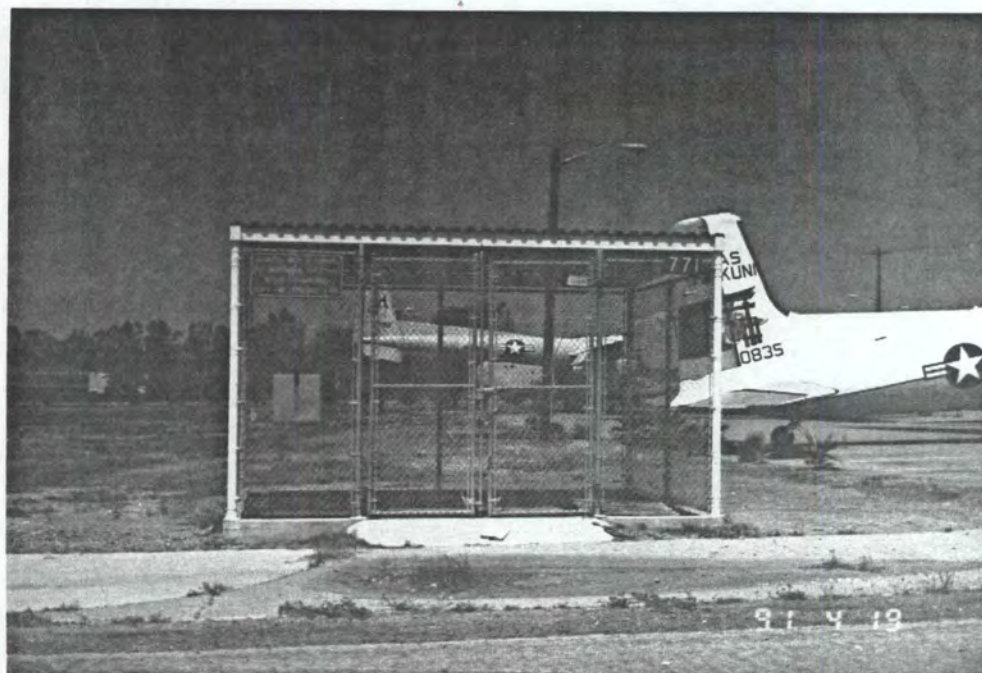
Name: Hazardous Waste Storage Area 771

This Hazardous Waste Storage Area (HWSA) is one of the six DHS-permitted HWSAs at MCAS El Toro. These six HWSAs (SWMU/AOC Numbers 222 through 227) are not planned for future use. Historically, these six HWSAs have had drums stored outside of the storage area.

The HWSA was not in use and appeared to have been inactive for a long time. No significant stains or cracks were observed.

Although there was no evidence of a release during the site visit and hazardous waste was not currently stored in the area, the past and present HWSAs at MCAS El Toro are recommended for a sampling visit.

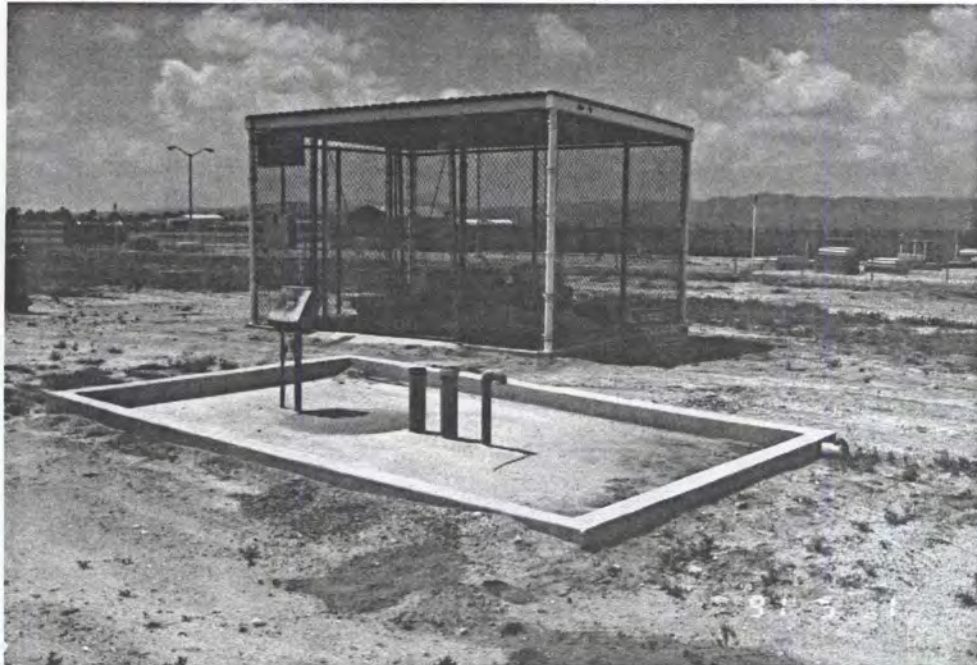
Name: Hazardous Waste Storage Area 779

Photodeveloper had leaked inside the storage area

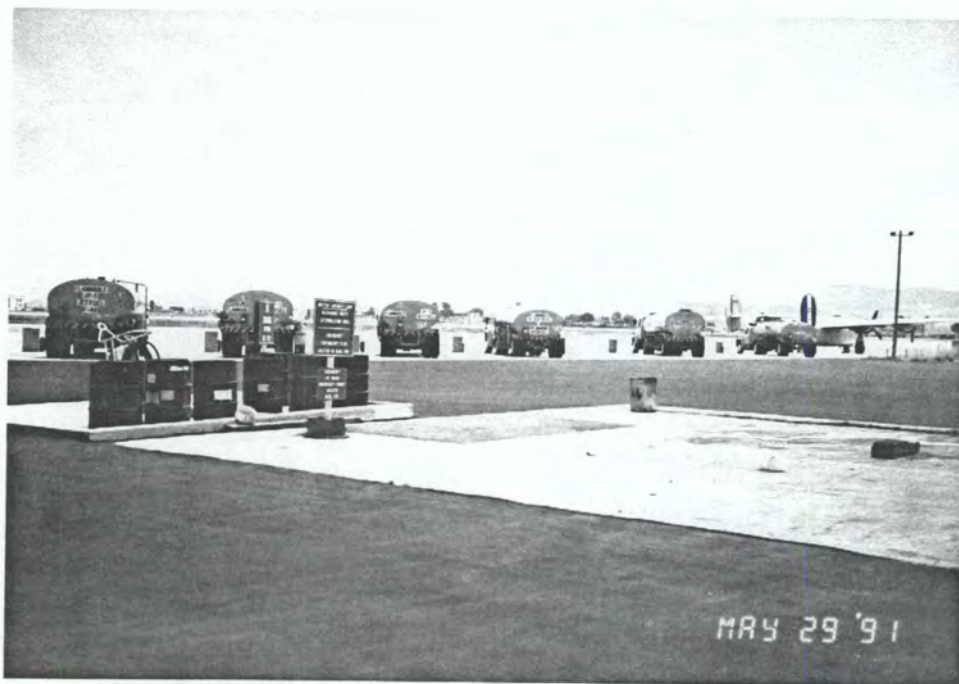
A washrack is located approximately 50 ft southeast of Building 240. The washrack consists of a concrete wash pad surrounded by a 6 inch concrete berm. A drain leading to oil/water separator 240-C (SWMU/AOC Number 66) is located near the northwest corner of the wash pad. The washrack surface has numerous dark stains. However, there are no significant cracks in the wash pad or the berm surrounding the washrack.

Stained wash pad

The washrack is constructed of concrete that is sloped to collect the wash water in a drain connected to an oil/water separator. The concrete appeared to be free of cracks or defects that would allow wash water to exit the washrack other than at the drain. No further action is recommended for this SWMU/AOC.

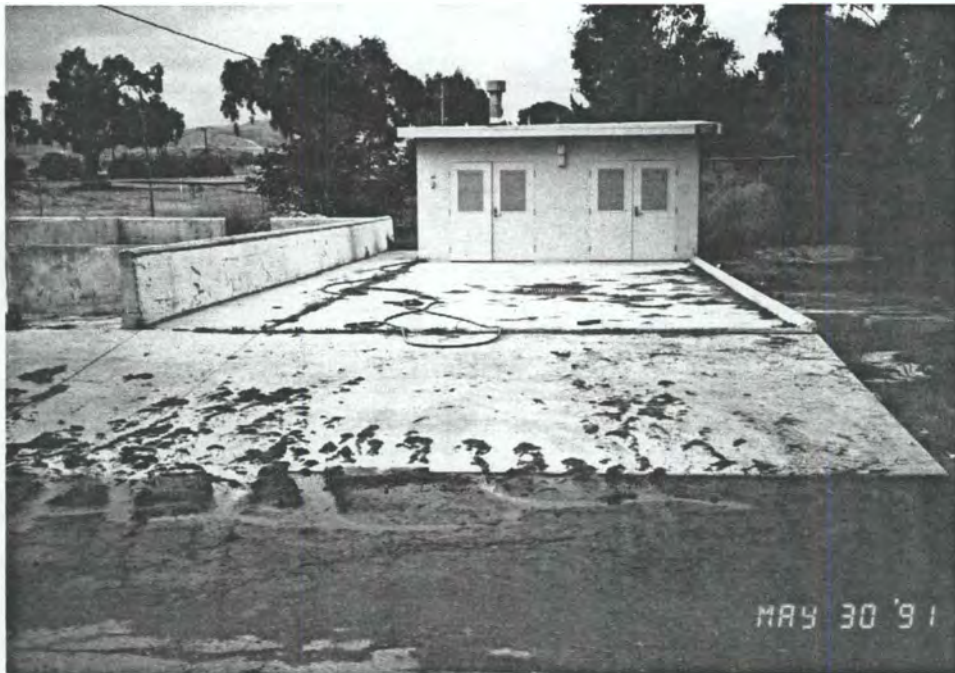
A washrack was observed during the VSI for oil/water separator 817 (SWMU/AOC Number 233). The washrack is located adjacent to the west side of Building 817. It is approximately 1,000 sq ft in size. The washrack consists of a concrete wash pad bordered by a 5-in. concrete berm on the south side of the washrack and a 3-ft concrete wall on the north side of the washrack. The washrack is graded so that runoff flows toward a drain centrally located within the wash pad. No significant stains or cracks were observed on the concrete wash surface. Vegetation was observed growing out from the drain leading to the oil/water separator.

During the site visit, it appeared that wash operations occurred outside of the washrack area and runoff of oily water had flowed to unpaved soil. A sampling visit is recommended for this SWMU/AOC.

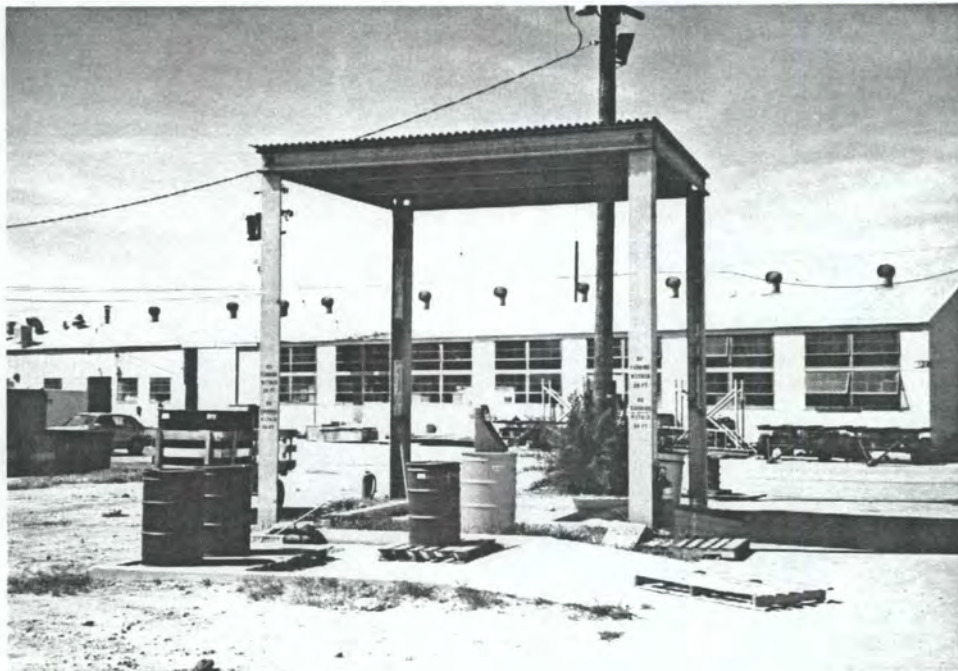
The HWSA is surrounded by unpaved soil on three sides and asphalt on the north side. A 3-ft by 8-ft stain was observed approximately 10 south of the HWSA, on unpaved soil.

A stain was observed near the HWSA on unpaved soil

A sampling visit is recommended for this HWSA.

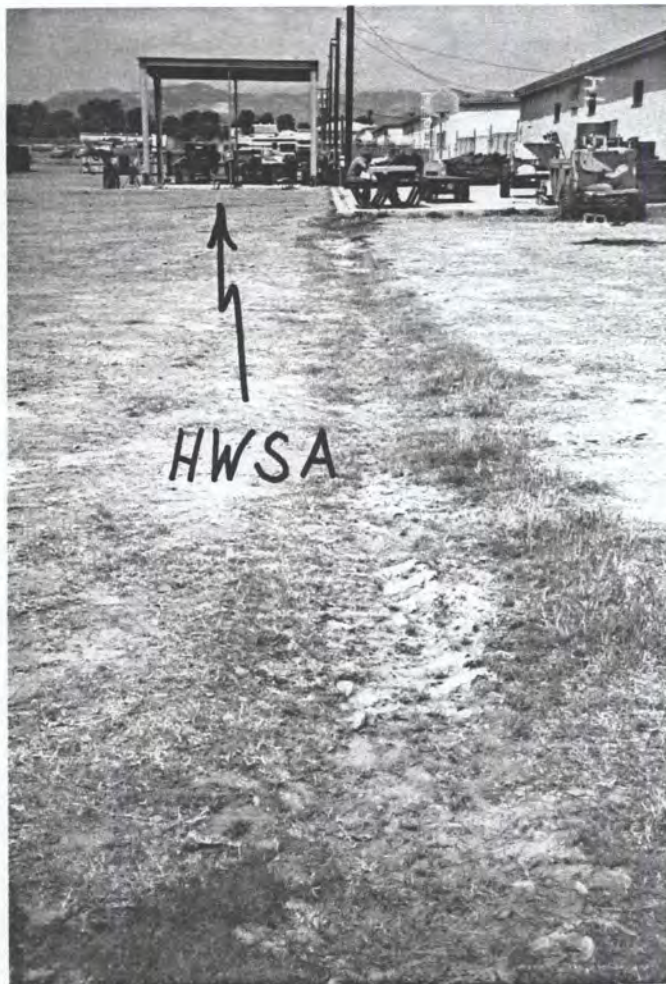
The hazardous waste storage area (HWSA) is located approximately 40 ft northwest of Building 31. The HWSA consists of a concrete pad with a 6-in. concrete berm. The HWSA has an aluminum roof covering and a sump. The HWSA is bordered on all sides by unpaved soil. There was no staining observed on the concrete pad or ground surface around the HWSA.

None observed

Although there is no evidence of a release at this HWSA, a sampling visit is recommended for the HWSAs at the Station.

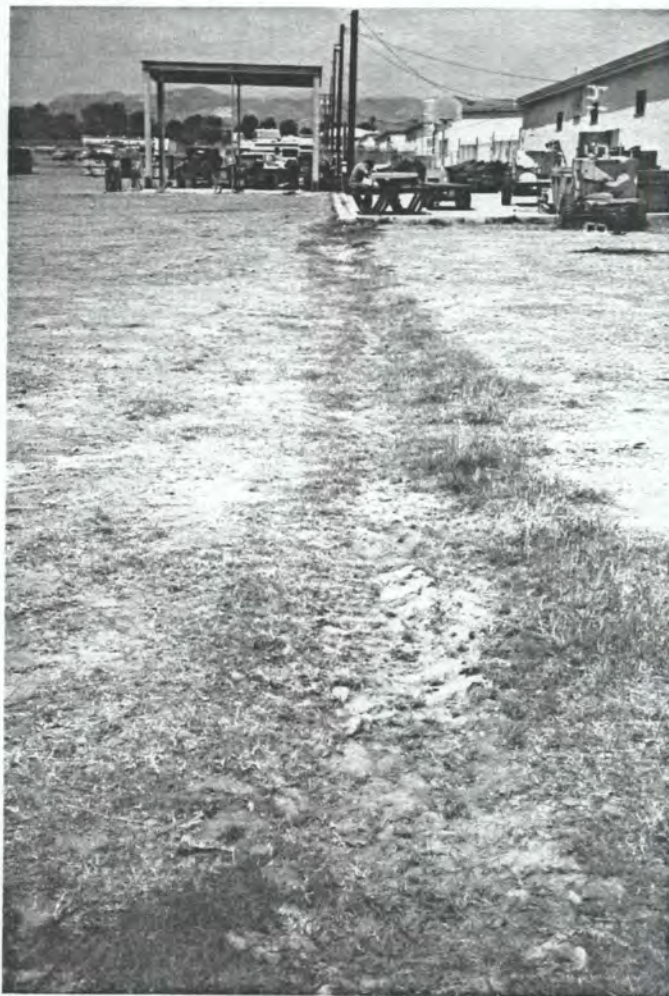
A wash area is located adjacent to the northwest side of Building 31. The wash area consists of a concrete pad measuring approximately 40 ft by 60 ft. No cracks or significant stains were observed on the concrete surface. The pad abuts Building 31 to the southeast and is bordered by unpaved soil on its remaining three sides. A 4-in. gutter is cut into the northwest side of the pad. The pad is sloped to the southwest thereby directing runoff into the drain and off the pad at an outlet located at the west corner of the pad. Runoff from the pad has created an eroded drainage-way to the southwest. The drainage-way originates at the west corner of the pad and leads southwest off the storage yard boundary.
